Manhole Inspection Summary

Manhole # S04AA2011MH

Insp Date: **6/26/06 8:06 AM**

Location Address: **3720 CLARINTH RD** Cross Street: **WILLIAMSON AVE**

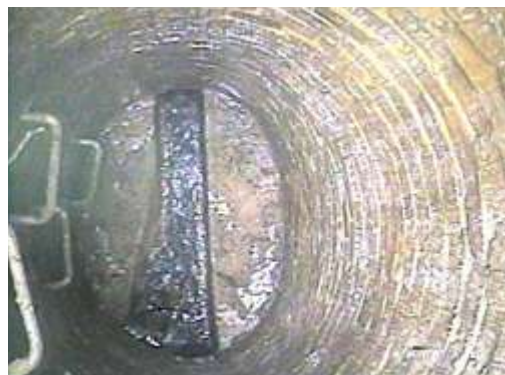
Top View

Corbel infiltration. Bench debris.

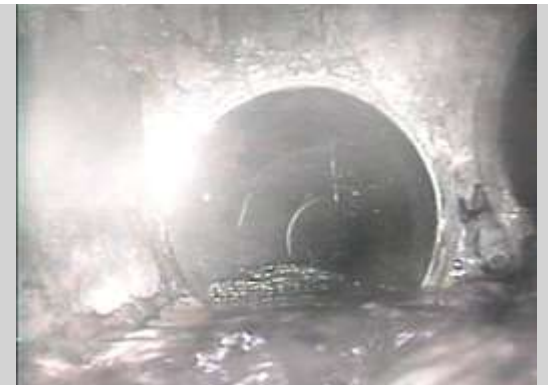
8 in. Circular Gravity Sewer Pipe In @ 6 O'Clock

Deposits: ☐ None ☐ Mud ☐ Sludge ☒ **Debris** ☐ Grease

Silt Depth: **0.25** (in.) Deposits Extent: **Medium**

Infiltration: **Evidence** Pipe Seal Cond: **Cracked**
